# Manhole Inspection Summary

Manhole # S21GG1001MH

**Location** Address: **1600 W 41ST ST**

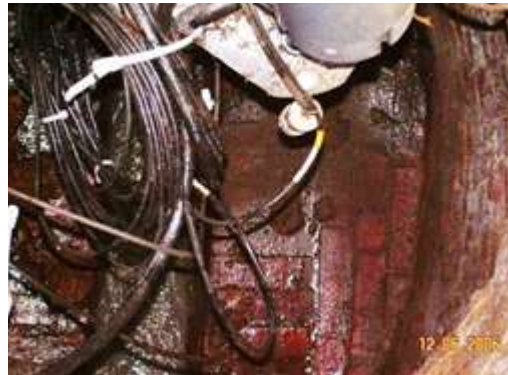
Top View

**Bench** ☒ Exists Material: **Brick** ☐ Parged ☒ **Debris** (not Condition related)

**Surcharge** ☒ **Evidence Of Surcharge** Depth: **1** (ft.) ☐ Active Surcharge Present

Evidence of surcharge - Bench debris.

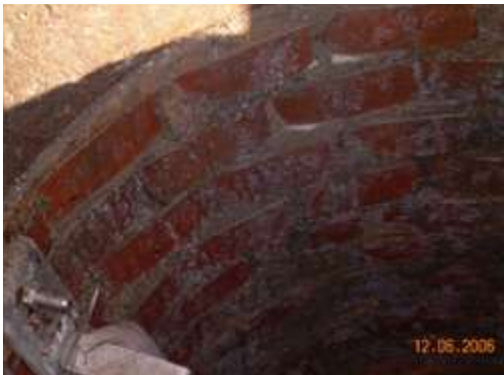
Defect

**Frame** Offset: **1** (in.) Condition: ☐ Sound ☐ Cracked ☒ **Leaks**

Infiltration: ☐ None ☒ **Joint** ☐ Cracks ☒ **Mortar** ☐ Roots ☐ Wall

Frame leaks. Adjustment infiltration.

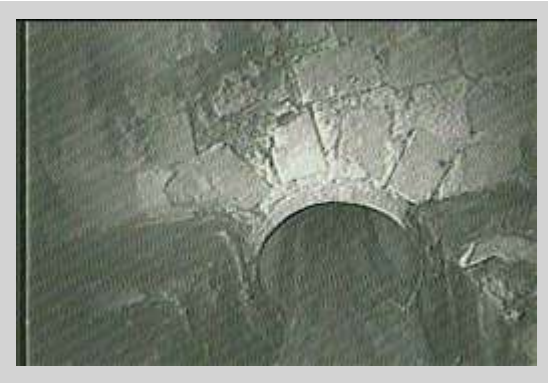
### 8 in. Circular Gravity Sewer Pipe Out @ 12 O'Clock

Barrel infiltration.
